Manhole Inspection Summary

Manhole # S250__001MH

Insp Date: **4/3/08 10:01 AM**

Location Address: **1200 BAYARD ST.**

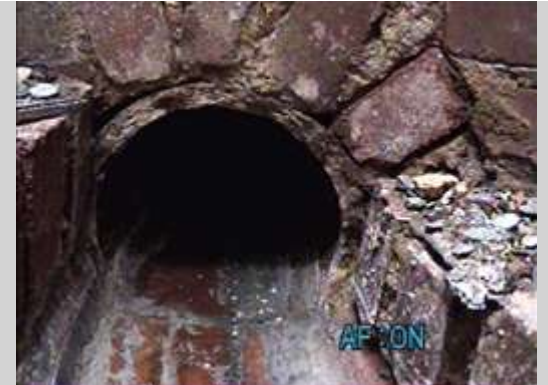
12 O'Clock Outflow

8 in. Circular Gravity Sewer
Pipe Out @ 12 O'Clock

Pipe Height: **8.4** (in.) Rod and Bar (Angled)
Pipe Material: **Clay** ☐ Pipe Lined
Invert Depth: **7.70** (ft.) Flow Characteristics: **Slow**
Deposits: ☒ None ☐ Mud ☐ Sludge ☐ Debris ☐ Grease
Silt Depth: **0** (in.) Deposits Extent:
Infiltration: **None** Pipe Seal Cond: **Sound**

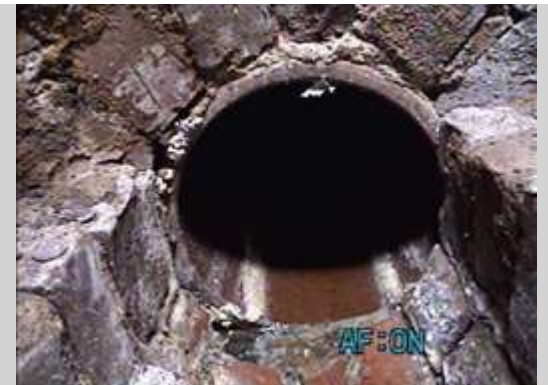
4 O'Clock Inflow

8 in. Circular Gravity Sewer
Pipe In @ 4 O'Clock

Pipe Height: **8.4** (in.) Rod and Bar (Angled)
Pipe Material: **Clay** ☐ Pipe Lined
Invert Depth: **7.56** (ft.) Flow Characteristics: **Slow**
Deposits: ☒ None ☐ Mud ☐ Sludge ☐ Debris ☐ Grease
Silt Depth: **0** (in.) Deposits Extent:
Infiltration: **None** Pipe Seal Cond: **Sound**
